Brandon Meara Report

Home Inspection Report

Monday, March 17, 2014

Shamrock Home Inspections
55 Sparrow Dr
Hamilton, NJ 08690
(609) 588-5558
shinsp@optonline.net

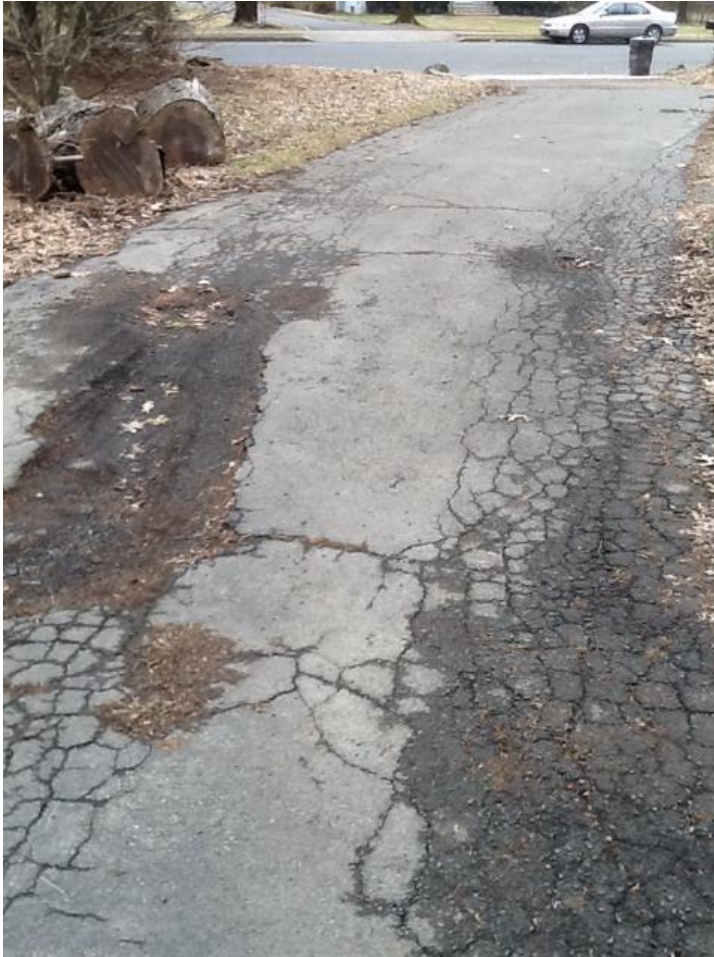
☐ None ☐ Not Visible
Material ☐ Concrete ☐ Asphalt ☐ Gravel/Dirt ☐ Brick ☐ Other:
Condition ☐ Satisfactory ☐ Marginal ☒ Poor ☐ Settling Cracks ☐ Typical cracks ☐ Pitched towards home
☒ Trip hazard ☐ Fill cracks and seal
Comments Driveway was in poor condition and in need of repair and/or replacement. Trip hazard in driveway, repair and/or replace as necessary.

Driveway was in poor condition and in need of repair and/or replacement. Trip hazard in driveway, repair and/or replace as necessary.

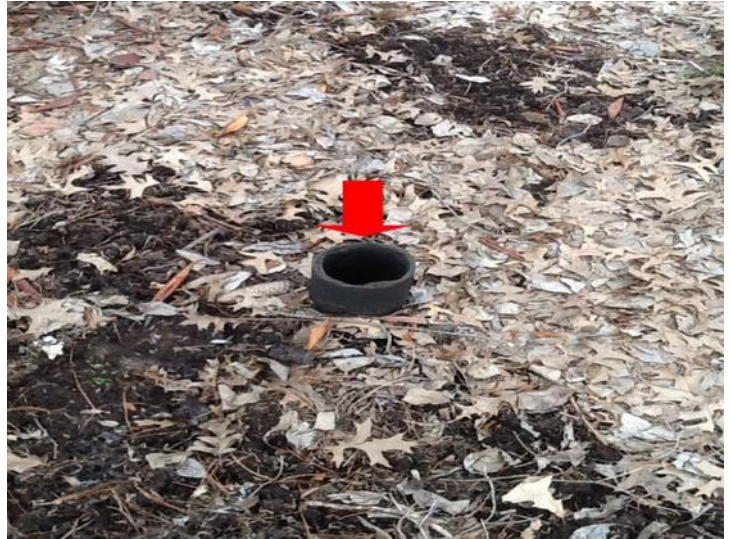
Appears to be a drain line at front yard - install proper cap

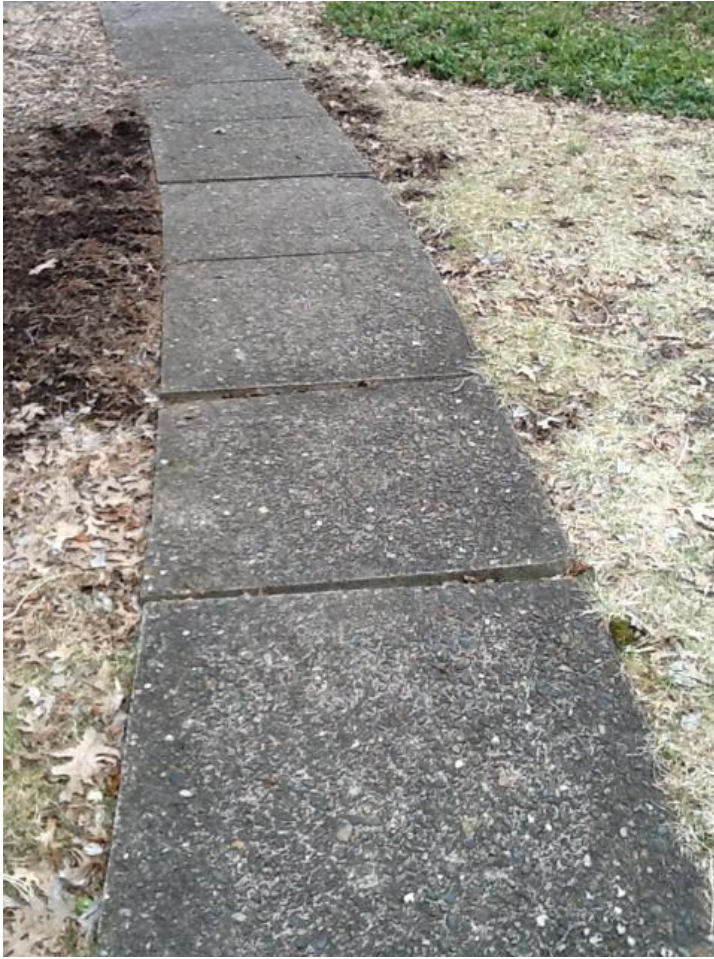
☐ None ☐ Not Visible
Material ☒ Concrete ☐ Flagstone ☐ Gravel ☐ Brick ☐ Other:
Condition ☐ Satisfactory ☐ Marginal ☐ Poor ☒ Trip hazard ☐ Typical cracks ☐ Pitched towards home
☐ Settling cracks ☐ Public sidewalk needs repair
Comments Uneven sidewalks, could be a tripping hazard, repair and/or replace as needed.

Uneven sidewalks, could be a tripping hazard, repair and/or replace as needed.

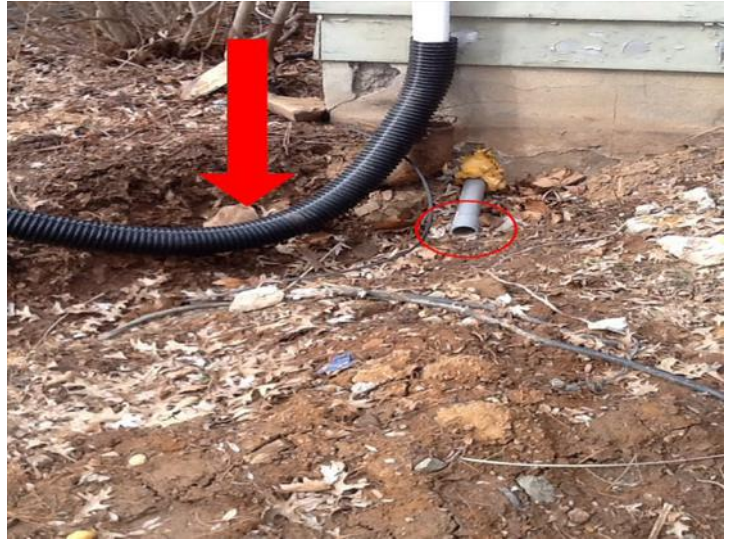
Comments Recommend window well covers. Correct grading so soil slopes from structure to direct water away and backfill SW area, seller stated it from digging up the past electric service. Cover exposed tree roots with soil to prevent a trip hazard.

Correct grading so soil slopes from structure to direct water away and backfill SW areas, seller stated it is from a past underground electric service that has been removed. Cap opened conduit at wall.

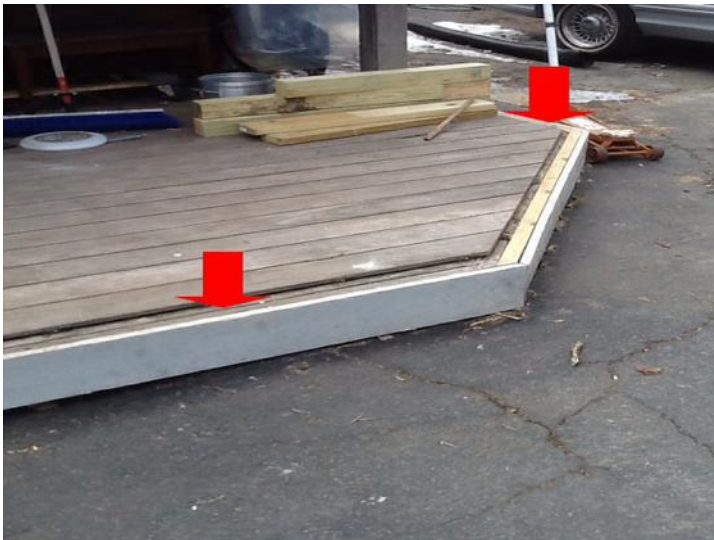
Install missing trim at deck perimeter

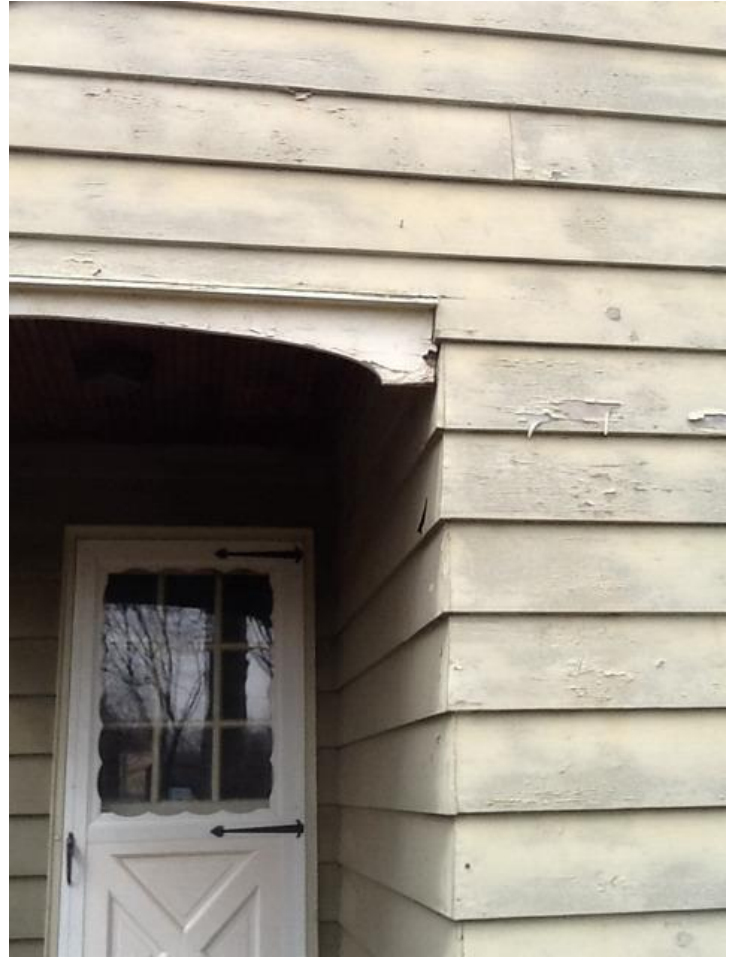
Material ☒ Wood ☐ Fiberboard ☐ Aluminum/Steel ☐ Vinyl ☐ Stucco ☒ Recommend repair/painting
☒ Damaged wood ☐ Other:
Condition ☐ Satisfactory ☐ Marginal ☒ Poor
Comments Trim has moisture damage and is in need of repair or replacement in areas. Caulk joints as needed to prevent water entry. Wood trim is weathered and paint peeling - painting/scraping is needed overall. Trim damage/missing at East fascia - repair as needed.

Trim has moisture damage and is in need of repair or replacement.
Siding and trim need painting.

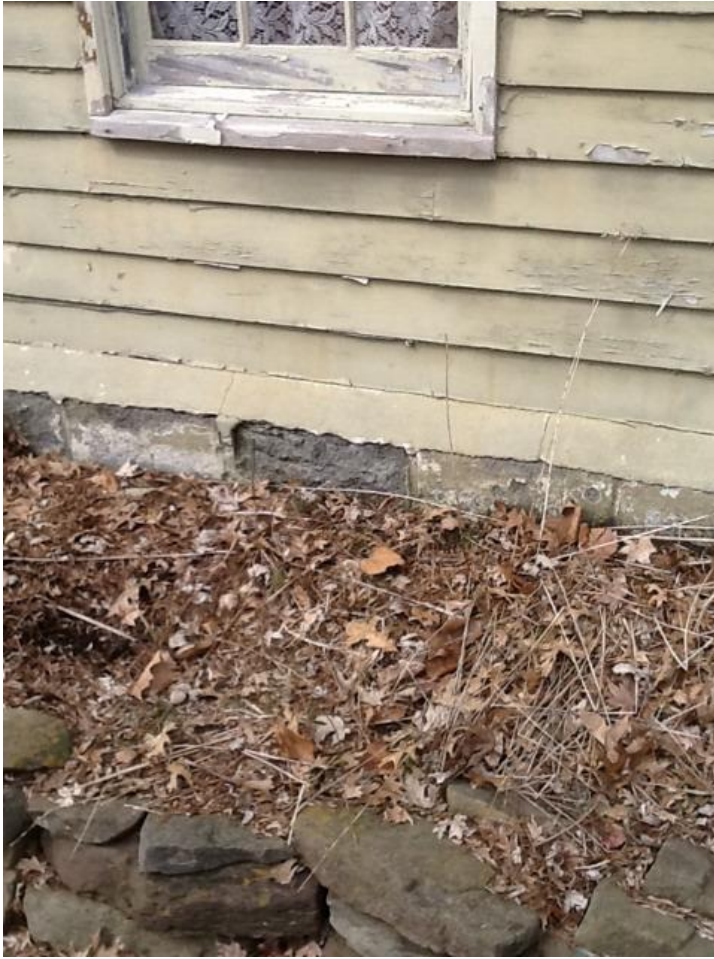
Surface deterioration to areas of exterior block foundation and walls - patch as needed

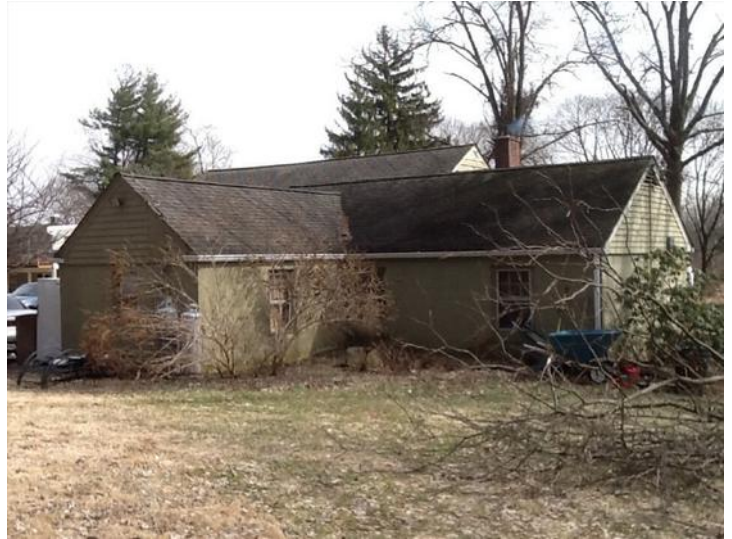
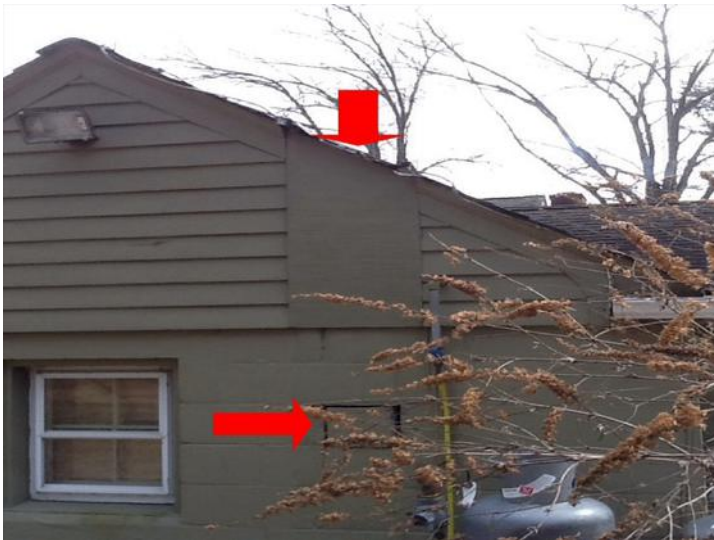
It appears there was a chimney at rear wall at one time and has been removed - patch roof shingles and block wall as needed.

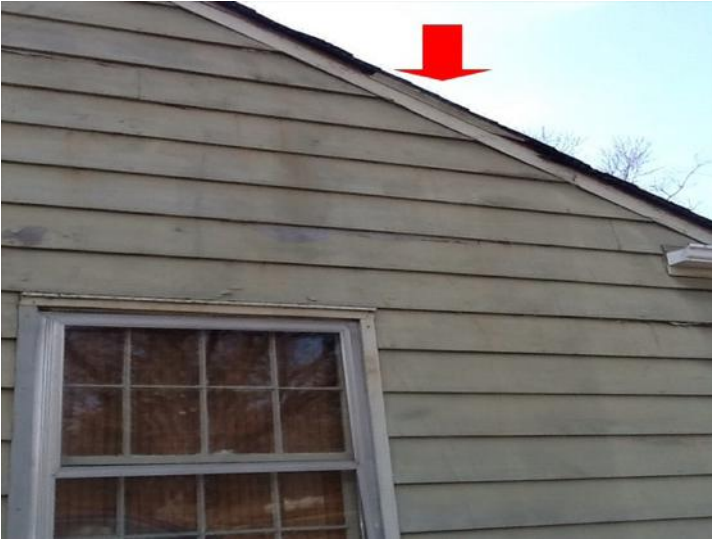
Trim damage/missing at East fascia

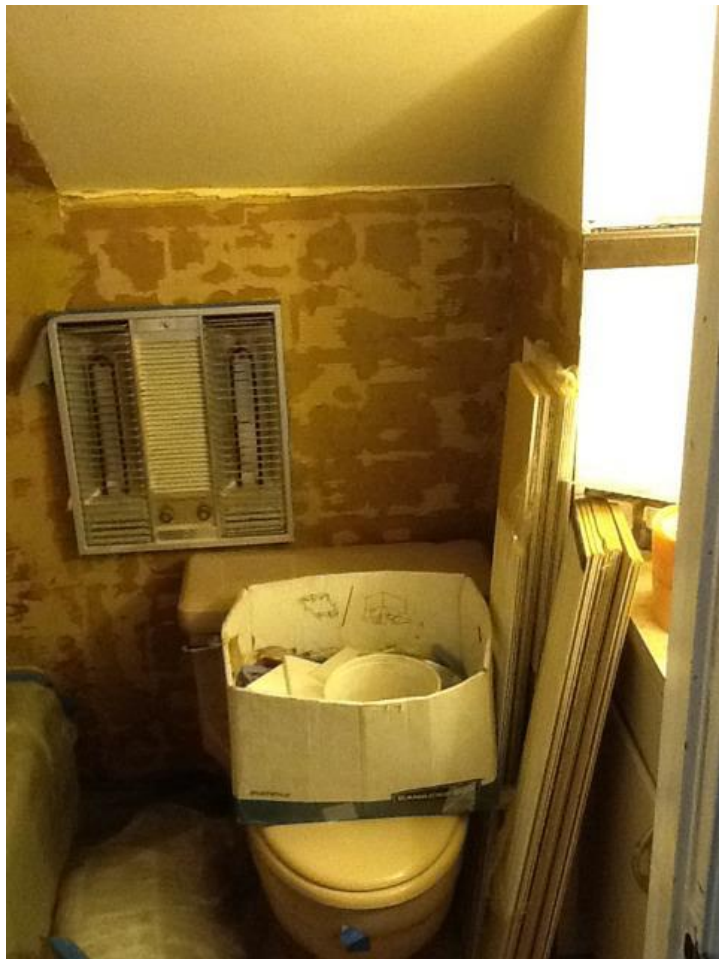
2nd floor

Comments Wall tiles and faucet have been removed at tub - repair as needed, it is not functional. Areas needs caulking/grouting. Exhaust fan not present, recommend installing. Evidence of past leakage under sink, no present leaks. Moderate wear to cabinet and countertop. Drains show no signs of back-up during time of inspection. No present leaks. No present cracks at tub enclosure. Electric wall heater fan was noisy. Heater is too close to tub, recommend removing.

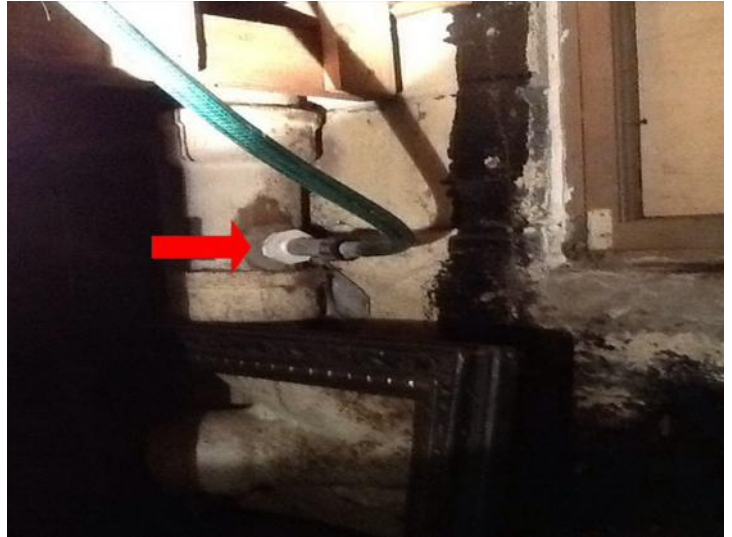
Sump pump ties into main drain line in basement - remove, cap and drain to exterior

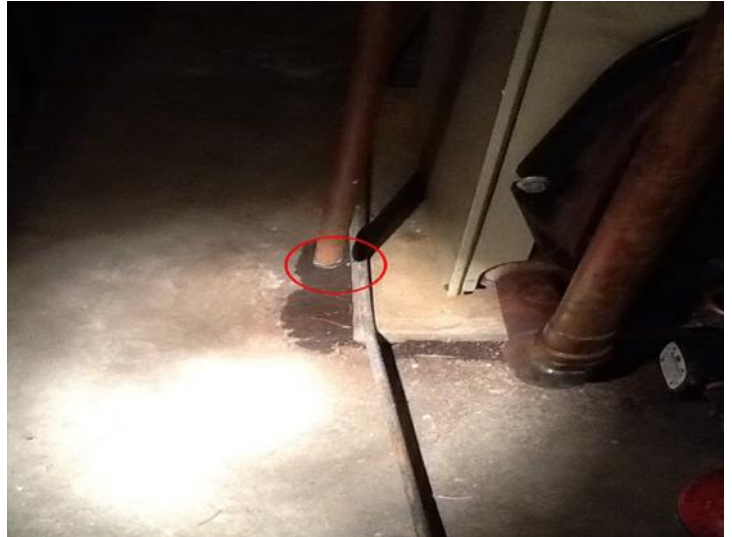
Repair leak at TPR valve and recommend servicing boiler system
